Flooding status in the Pittsburgh Seam - Glover Gap, WV, Quadrangle

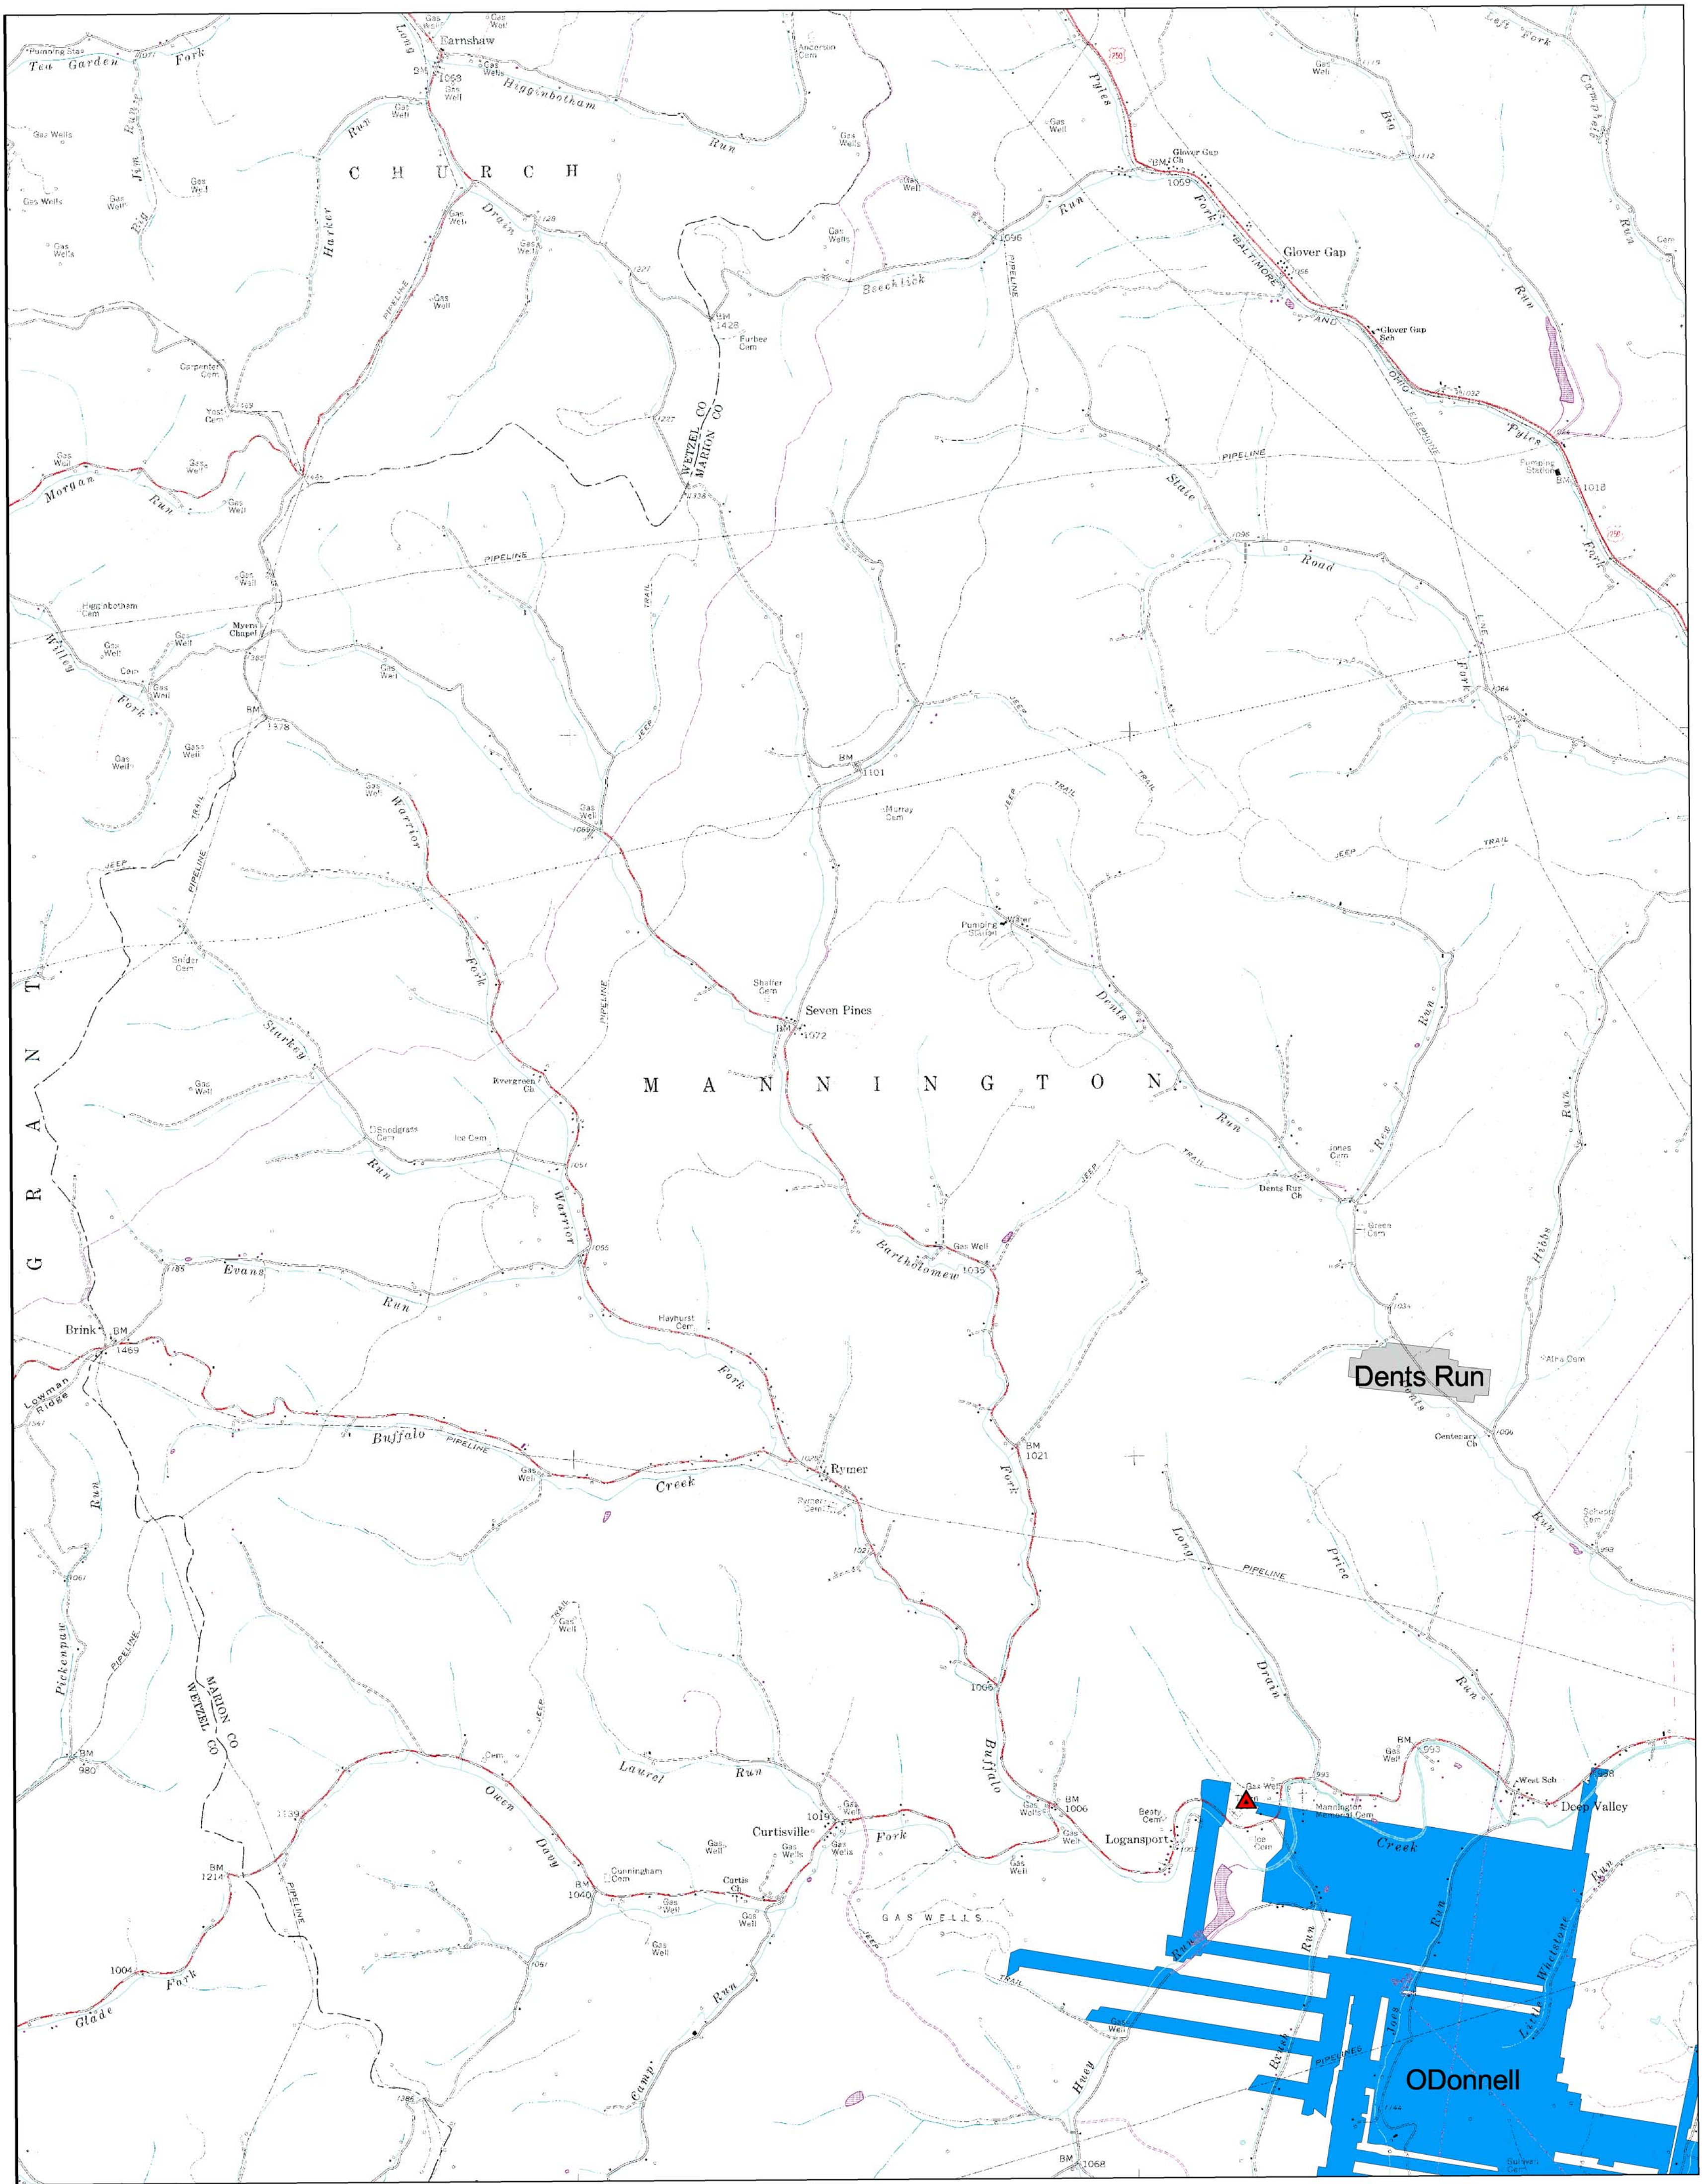
Colored areas are underground mining indicated on company maps; uncolored areas are unmined areas (including pillars and barriers), except that the areas between the indicated mines and the surface outcrop are probably mined.

This mapping is a reasonable, but not exact, facsimile of the distribution of underground mined areas. Mine map outlines were compiled from a variety of original and secondary sources of varying accuracy. While the absolute accuracy of specific barrier locations, mine outlines, and unmined coal blocks may not easily be estimated, it may be considered to typically range from 30-100 meters. Mine features have been generalized; individual mains, longwall panels, and pillars are not explicitly shown. Unmined coal blocks within mines were mapped only if their total area was greater than about 40 acres.
