Flooding status in the Pittsburgh Seam - Prosperity, PA, Quadrangle

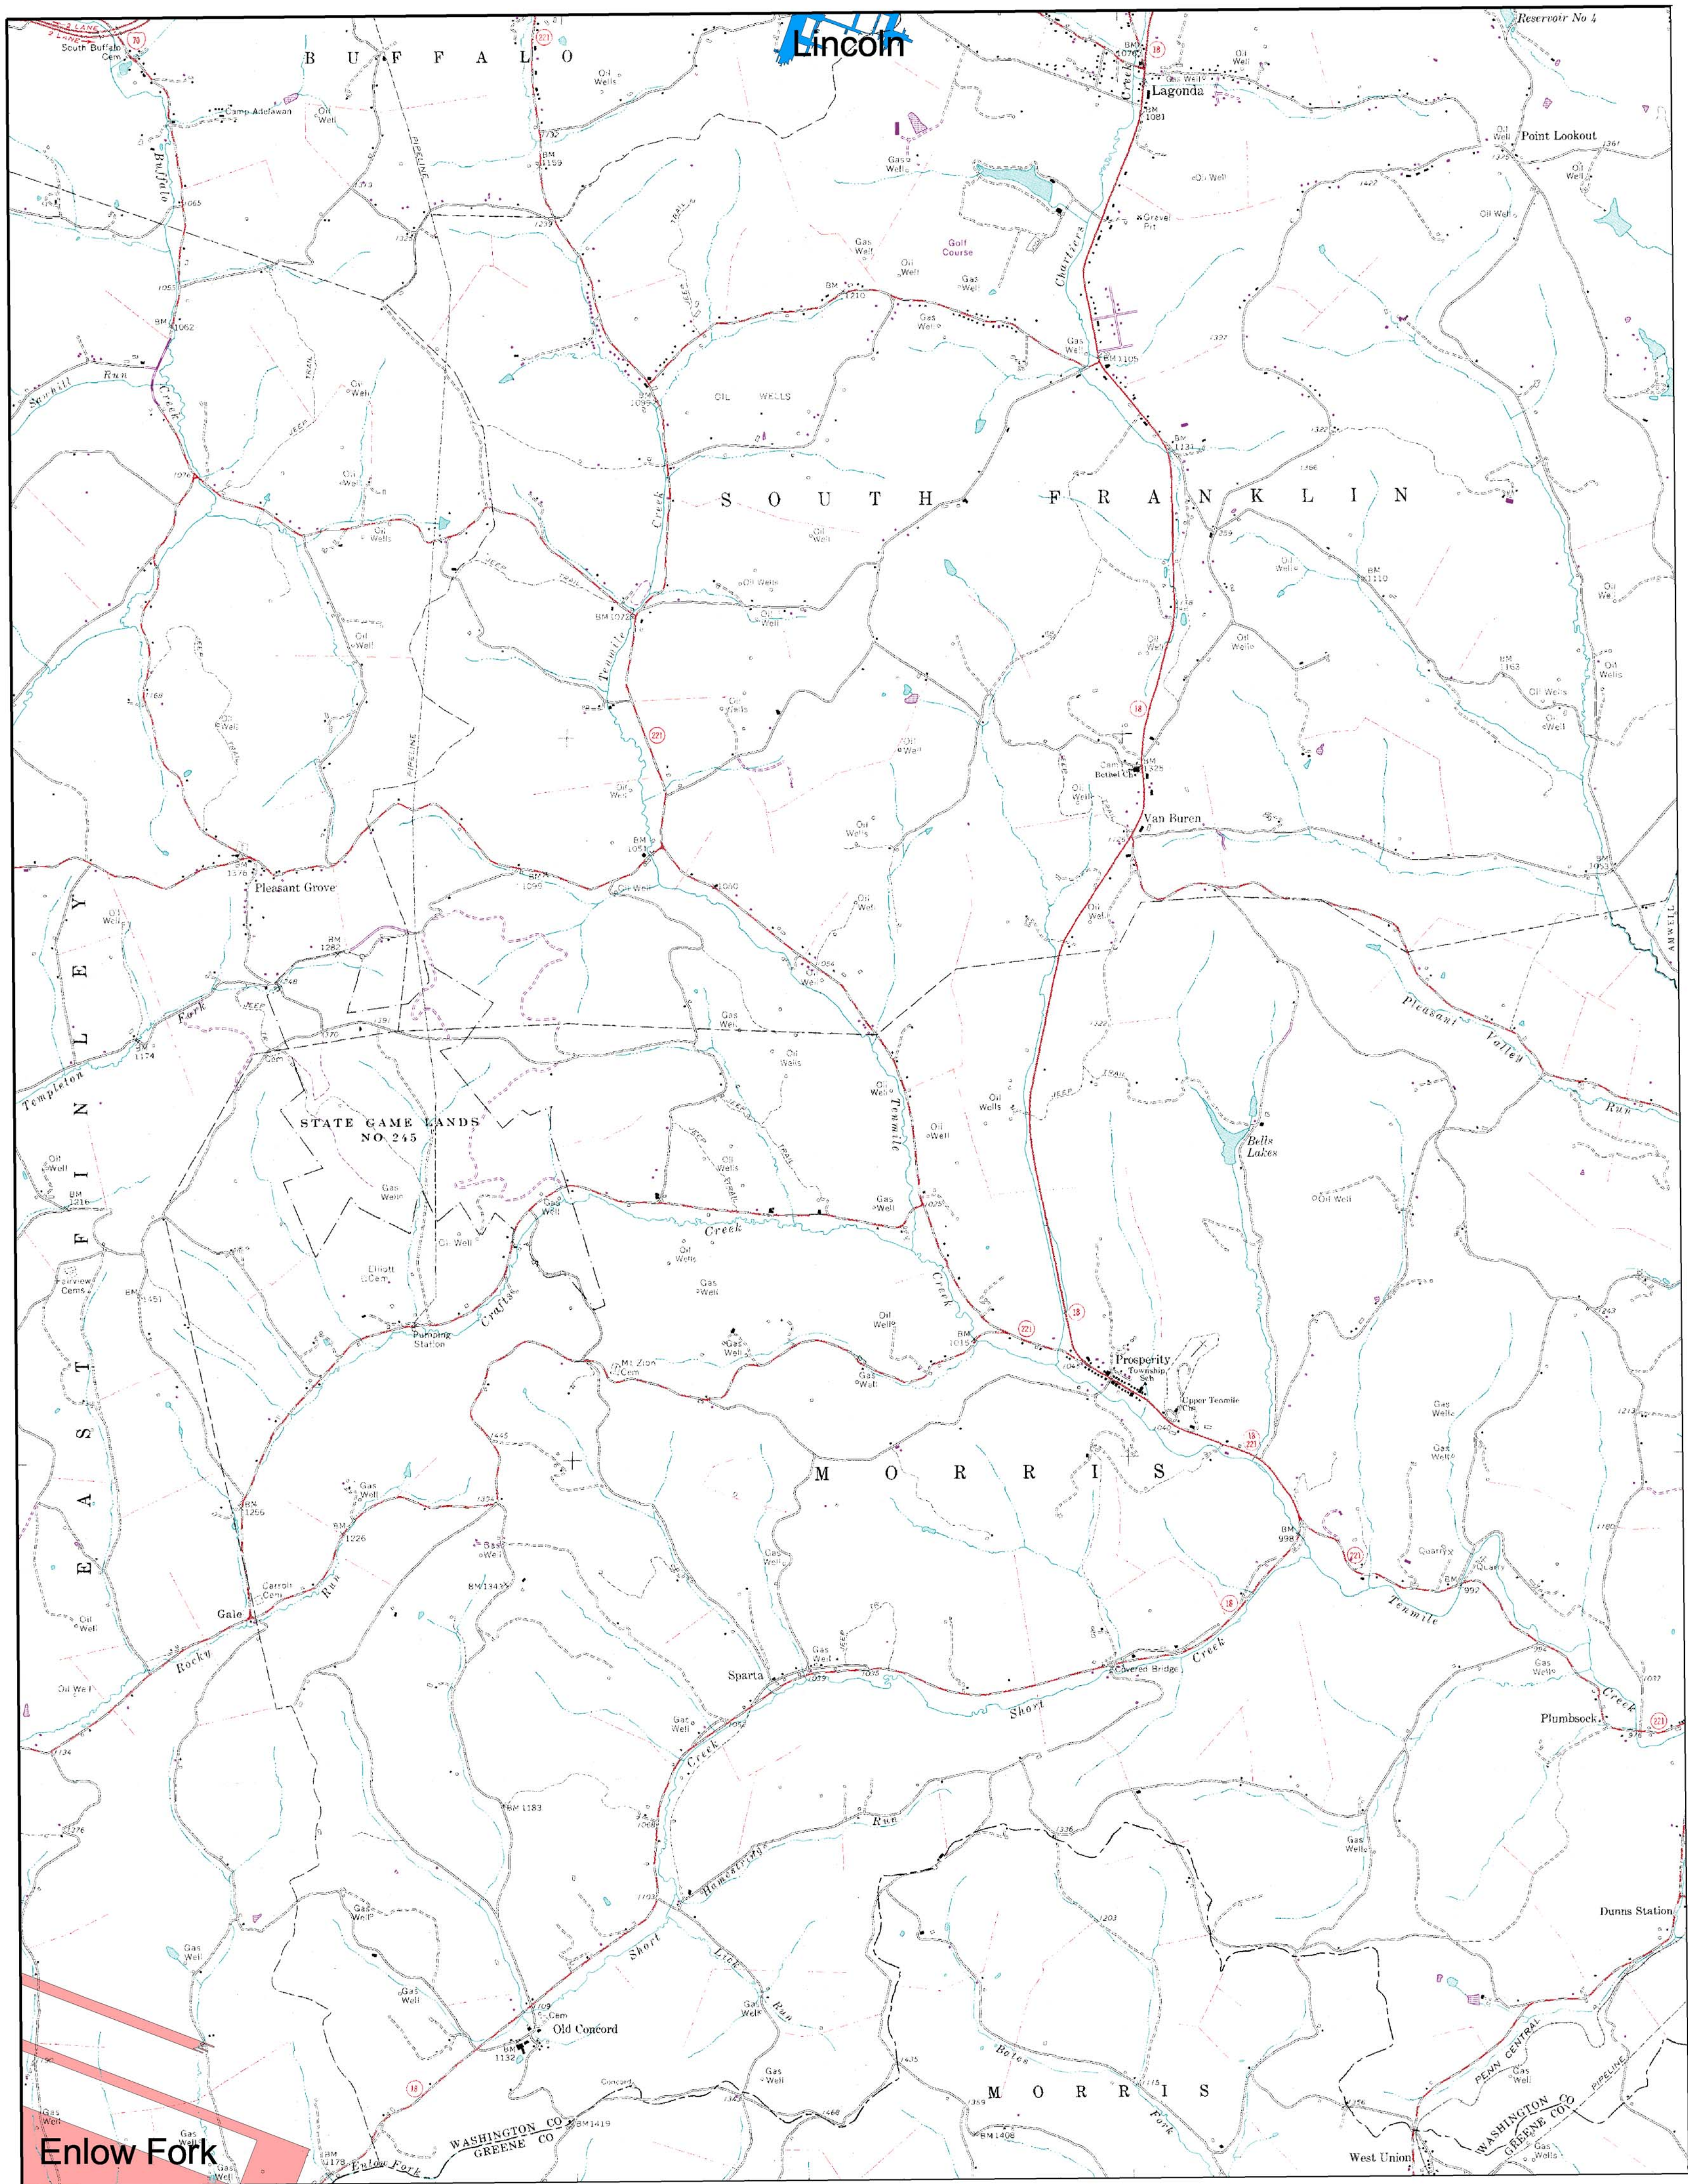
Colored areas are underground mining indicated on company maps; uncolored areas are unmined areas (including pillars and barriers), except that the areas between the indicated mines and the surface outcrop are probably mined.

This mapping is a reasonable, but not exact, facsimile of the distribution of underground mined areas. Mine map outlines were compiled from a variety of original and secondary sources of varying accuracy. While the absolute accuracy of specific barrier locations, mine outlines, and unmined coal blocks may not easily be estimated, it may be considered to typically range from 30-100 meters. Mine features have been generalized; individual mains, longwall panels, and pillars are not explicitly shown. Unmined coal blocks within mines were mapped only if their total area was greater than about 40 acres.
